HALLSANDS

V.J. May

OS Grid Reference: SX819382

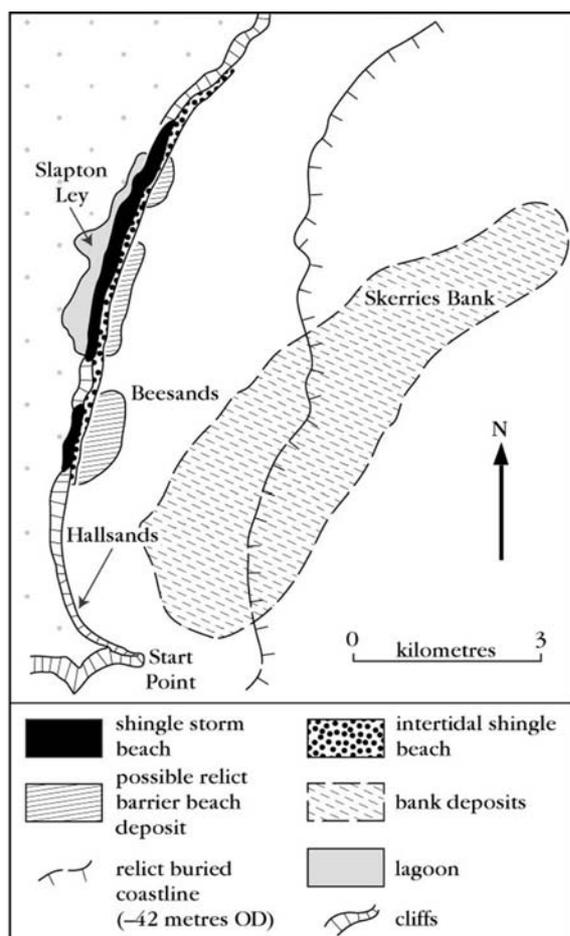
Figure 6.6: Hallsands and Slapton Sands represent parts of a once-continuous gravel beach. Offshore, there is evidence of buried shorelines and a possible former barrier beach. The present-day shingle beach is separated by rock headlands. (After Hails, 1975a.)

Hallsands lies at the south-western end of Start Bay (Figure 6.6); the scientific interest in this site arises from:

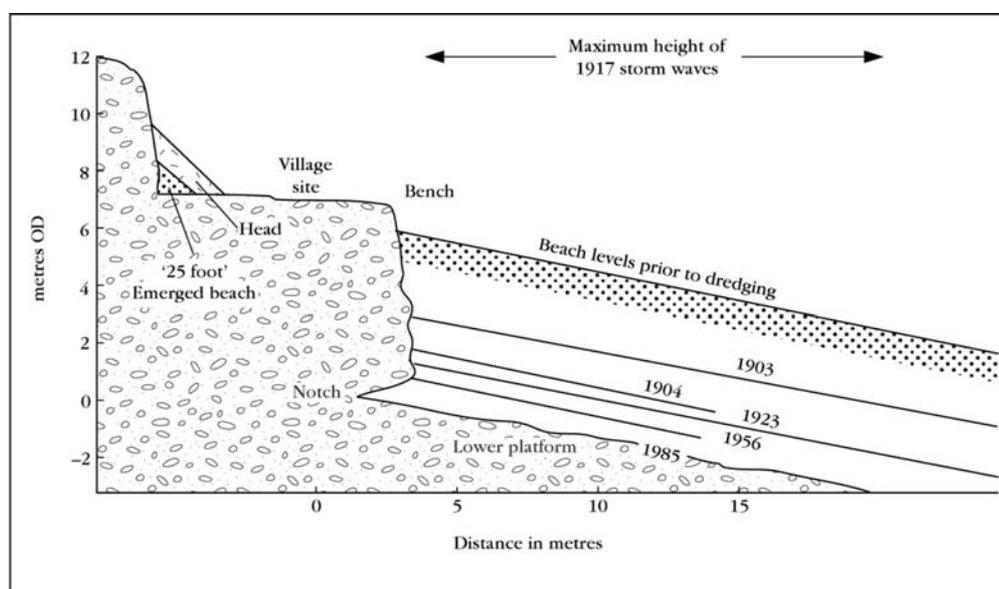
Figure 6.9: Cross-section of beach at Hallsands, showing the historic beach levels prior to dredging. (After Mottershead, 1986.)

The site is about 500 m in length, and is part of a cliffed shoreline between Start Point and Hallsands. Although the cliffs have a slope-over-wall form, the lower wall is distinguished at locations such as Hallsands by a bench about 7 m in height above sea level (Figure 6.9). Photographs in Mottershead (1986) show that the village stood on the rock bench, about 1–2 m above the shingle beach, contrary to the impression given by the beach profiles in Worth (1904), Robinson (1961) and Goudie and Gardiner (1985) that the beach and platform were a continuous unbroken form. Robinson (1961) described the rock bench as a wave-cut bench overlain by a considerable thickness of head. The bench is discontinuous, with promontories separated by deep ravines. At two locations, emerged beach deposits with bands of rounded pebbles occur beneath the head. The steeply sloping cliffs behind the bench have been modified by solifluction since their formation.

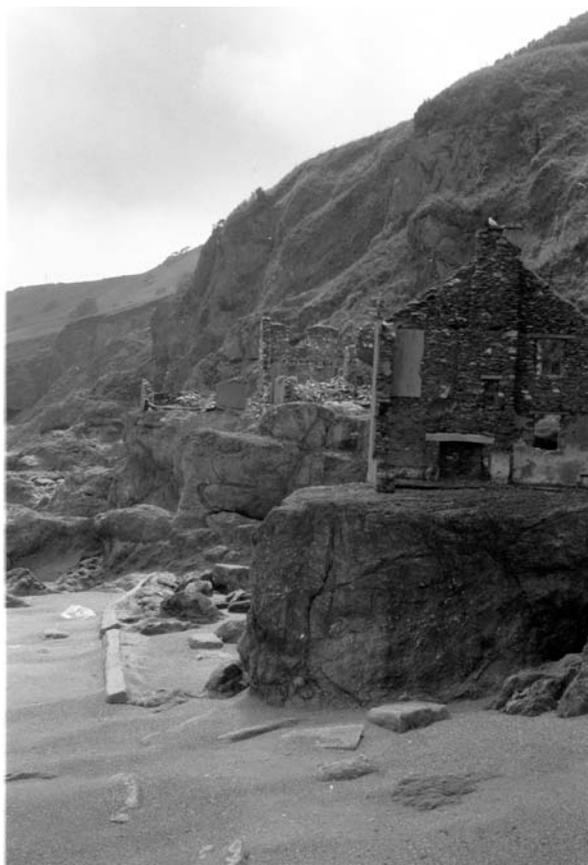
Figure 6.10: The ruins of the landward row of the houses of the former village of Hallsands. The seaward row of houses has completely disappeared. Compare with Figure 6.9. (Photo: V.J. May.)
